RE: *Desktop Water Table Study*
Town of Happy Valley-Goose Bay

Happy Valley-Goose Bay Desktop Water Table Study

Project No: 213037.00

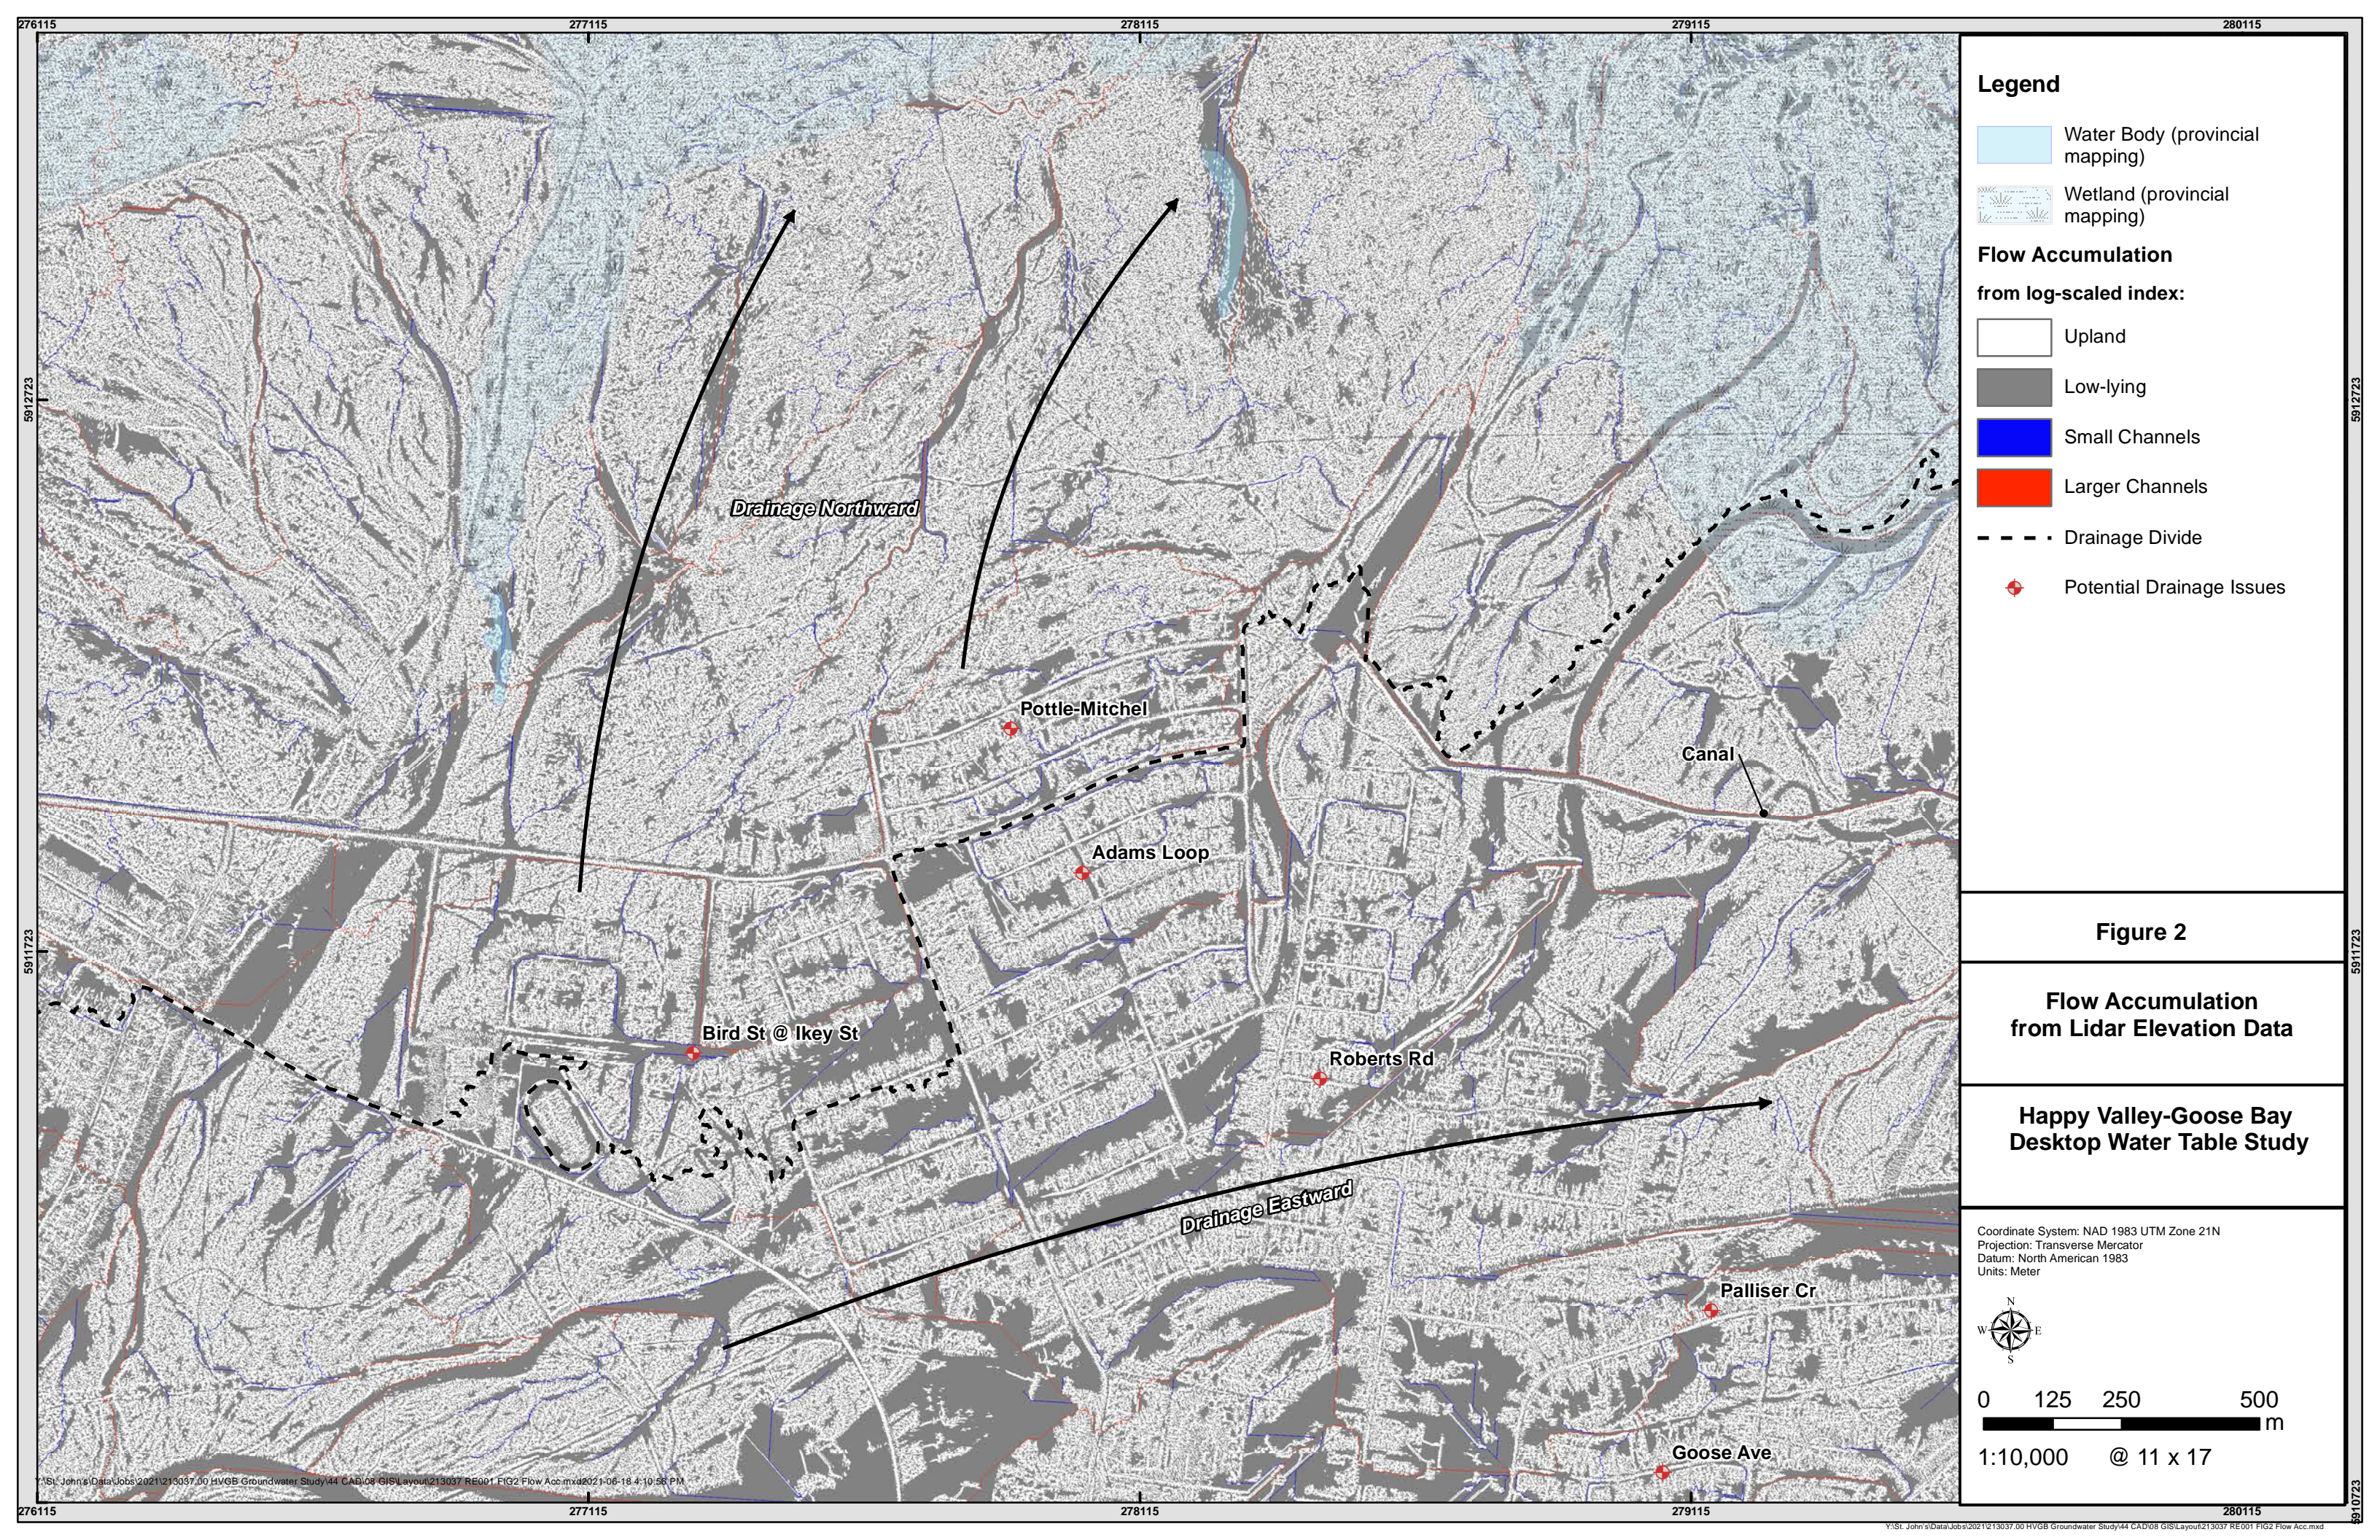
Provincial mapping shows an extensive wetland complex to the north of the Town, with major drainage channels feeding these water bodies. An analysis of high-resolution Lidar elevation data indicated the existence of more localized channels, forming a network that drains primarily eastward (Figure 2). One system to the west of the Town drains effectively northward. There is a canal to the north of Kelland Drive which was excavated to facilitate drainage of surface water eastward, following the natural gradient of this system. Precipitation originating in the Pottle Crescent subdivision appears to drain northward, whereas systems to the south of Kelland Drive and in the immediate vicinity of the canal drain eastward. The flow accumulation analysis does not account for culverts and may not represent all continuous channels at local scales.

Storm water ditches and culverts along many roads in the area have been observed to be partially or completely in-filled. Some culverts are noted to be obstructed. In general, the natural grade in developed parts of the Town is so low that surface water does not drain readily following snow melt or heavy rainfall. Trouble areas noted previously by the Town are shown in Figure 2 and include:

- ▶ Crawl spaces and basements in the Pottle Street – Mitchel subdivision;
- ▶ A low-lying zone on Palliser Crescent;
- ▶ The area in the centre of Adams Loop;
- ▶ The subdivision near Roberts Road; and
- ▶ A low-lying zone at the intersection of Bird Street and Ikey Street.

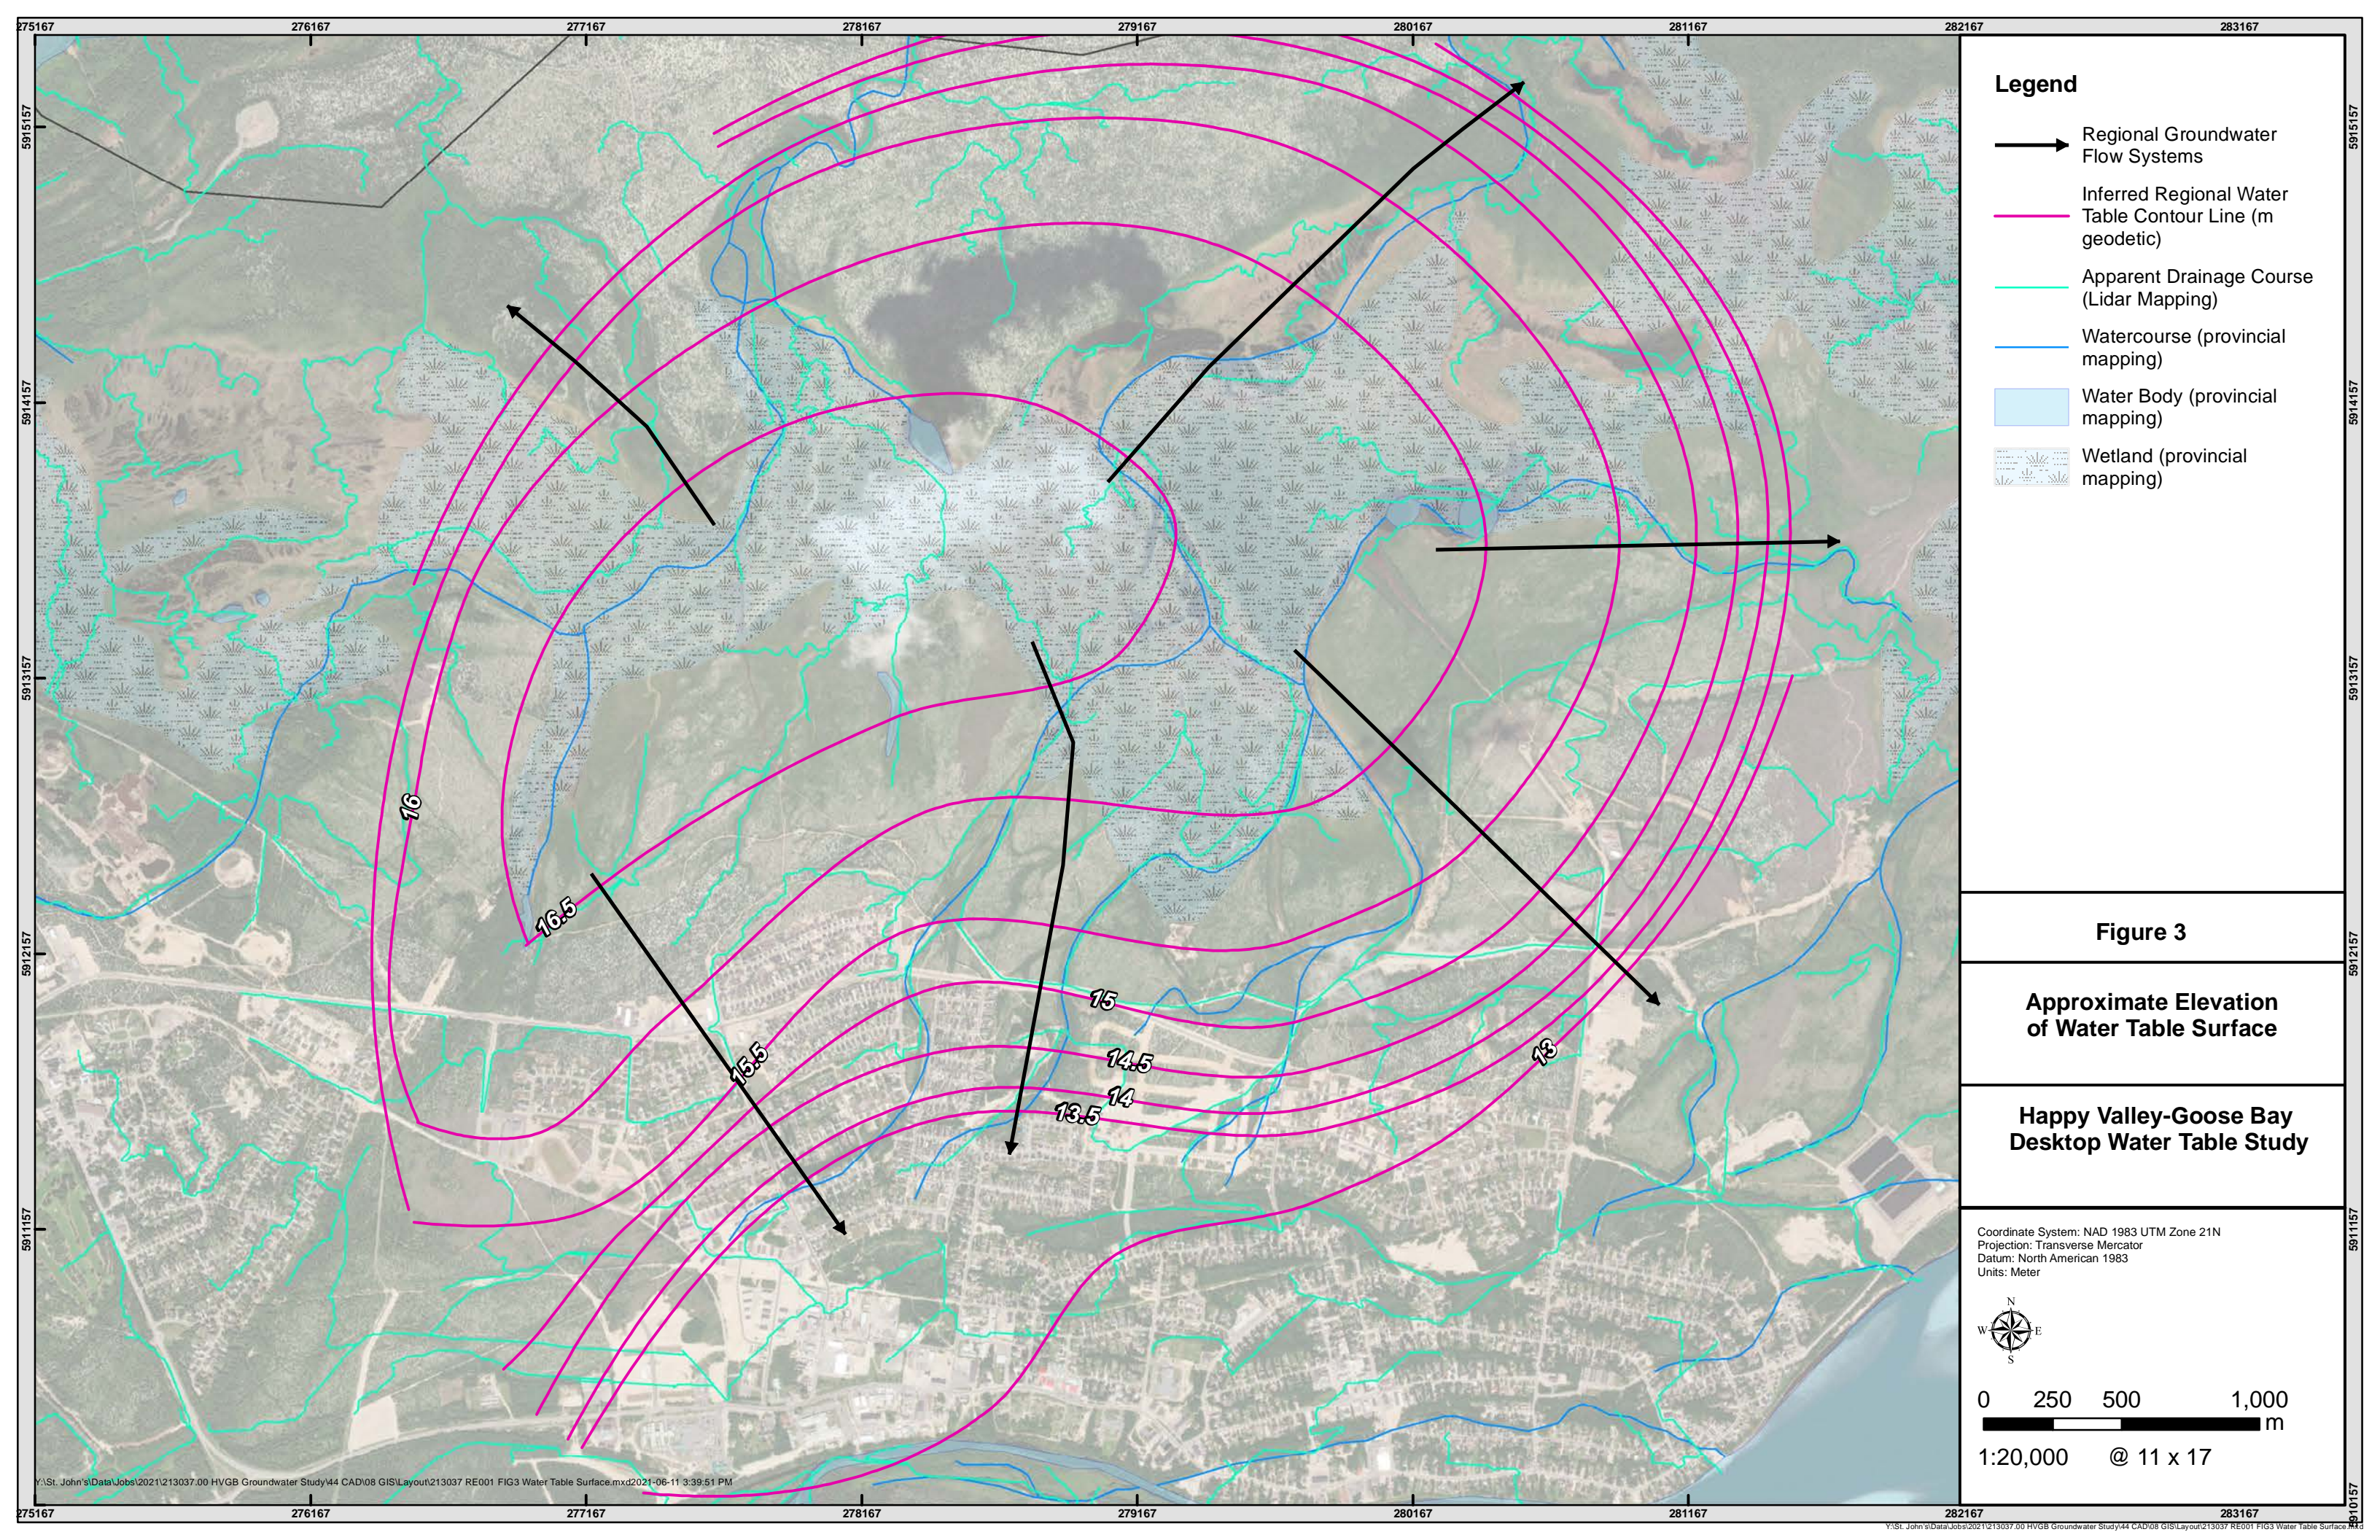
The regional water table surface was interpolated using Lidar elevation data, the flow accumulation analysis shown in Figure 2, and aerial photography. The water table is interpreted to be positioned within a regional unit of glaciofluvial sands, comprising a relatively consistent and uniform shallow flow system. The interpolated water table is shown in Figure 3 and is consistent with a conventional conceptual model of groundwater flow. Higher topography and wetland areas to the north of the town represent a regional groundwater recharge area. The large wetlands may store and attenuate surface water drainage, acting as a focused recharged area. Groundwater flow is expected to be predominantly horizontal and radially outward from this recharge zone, with discharge to the coastlines.

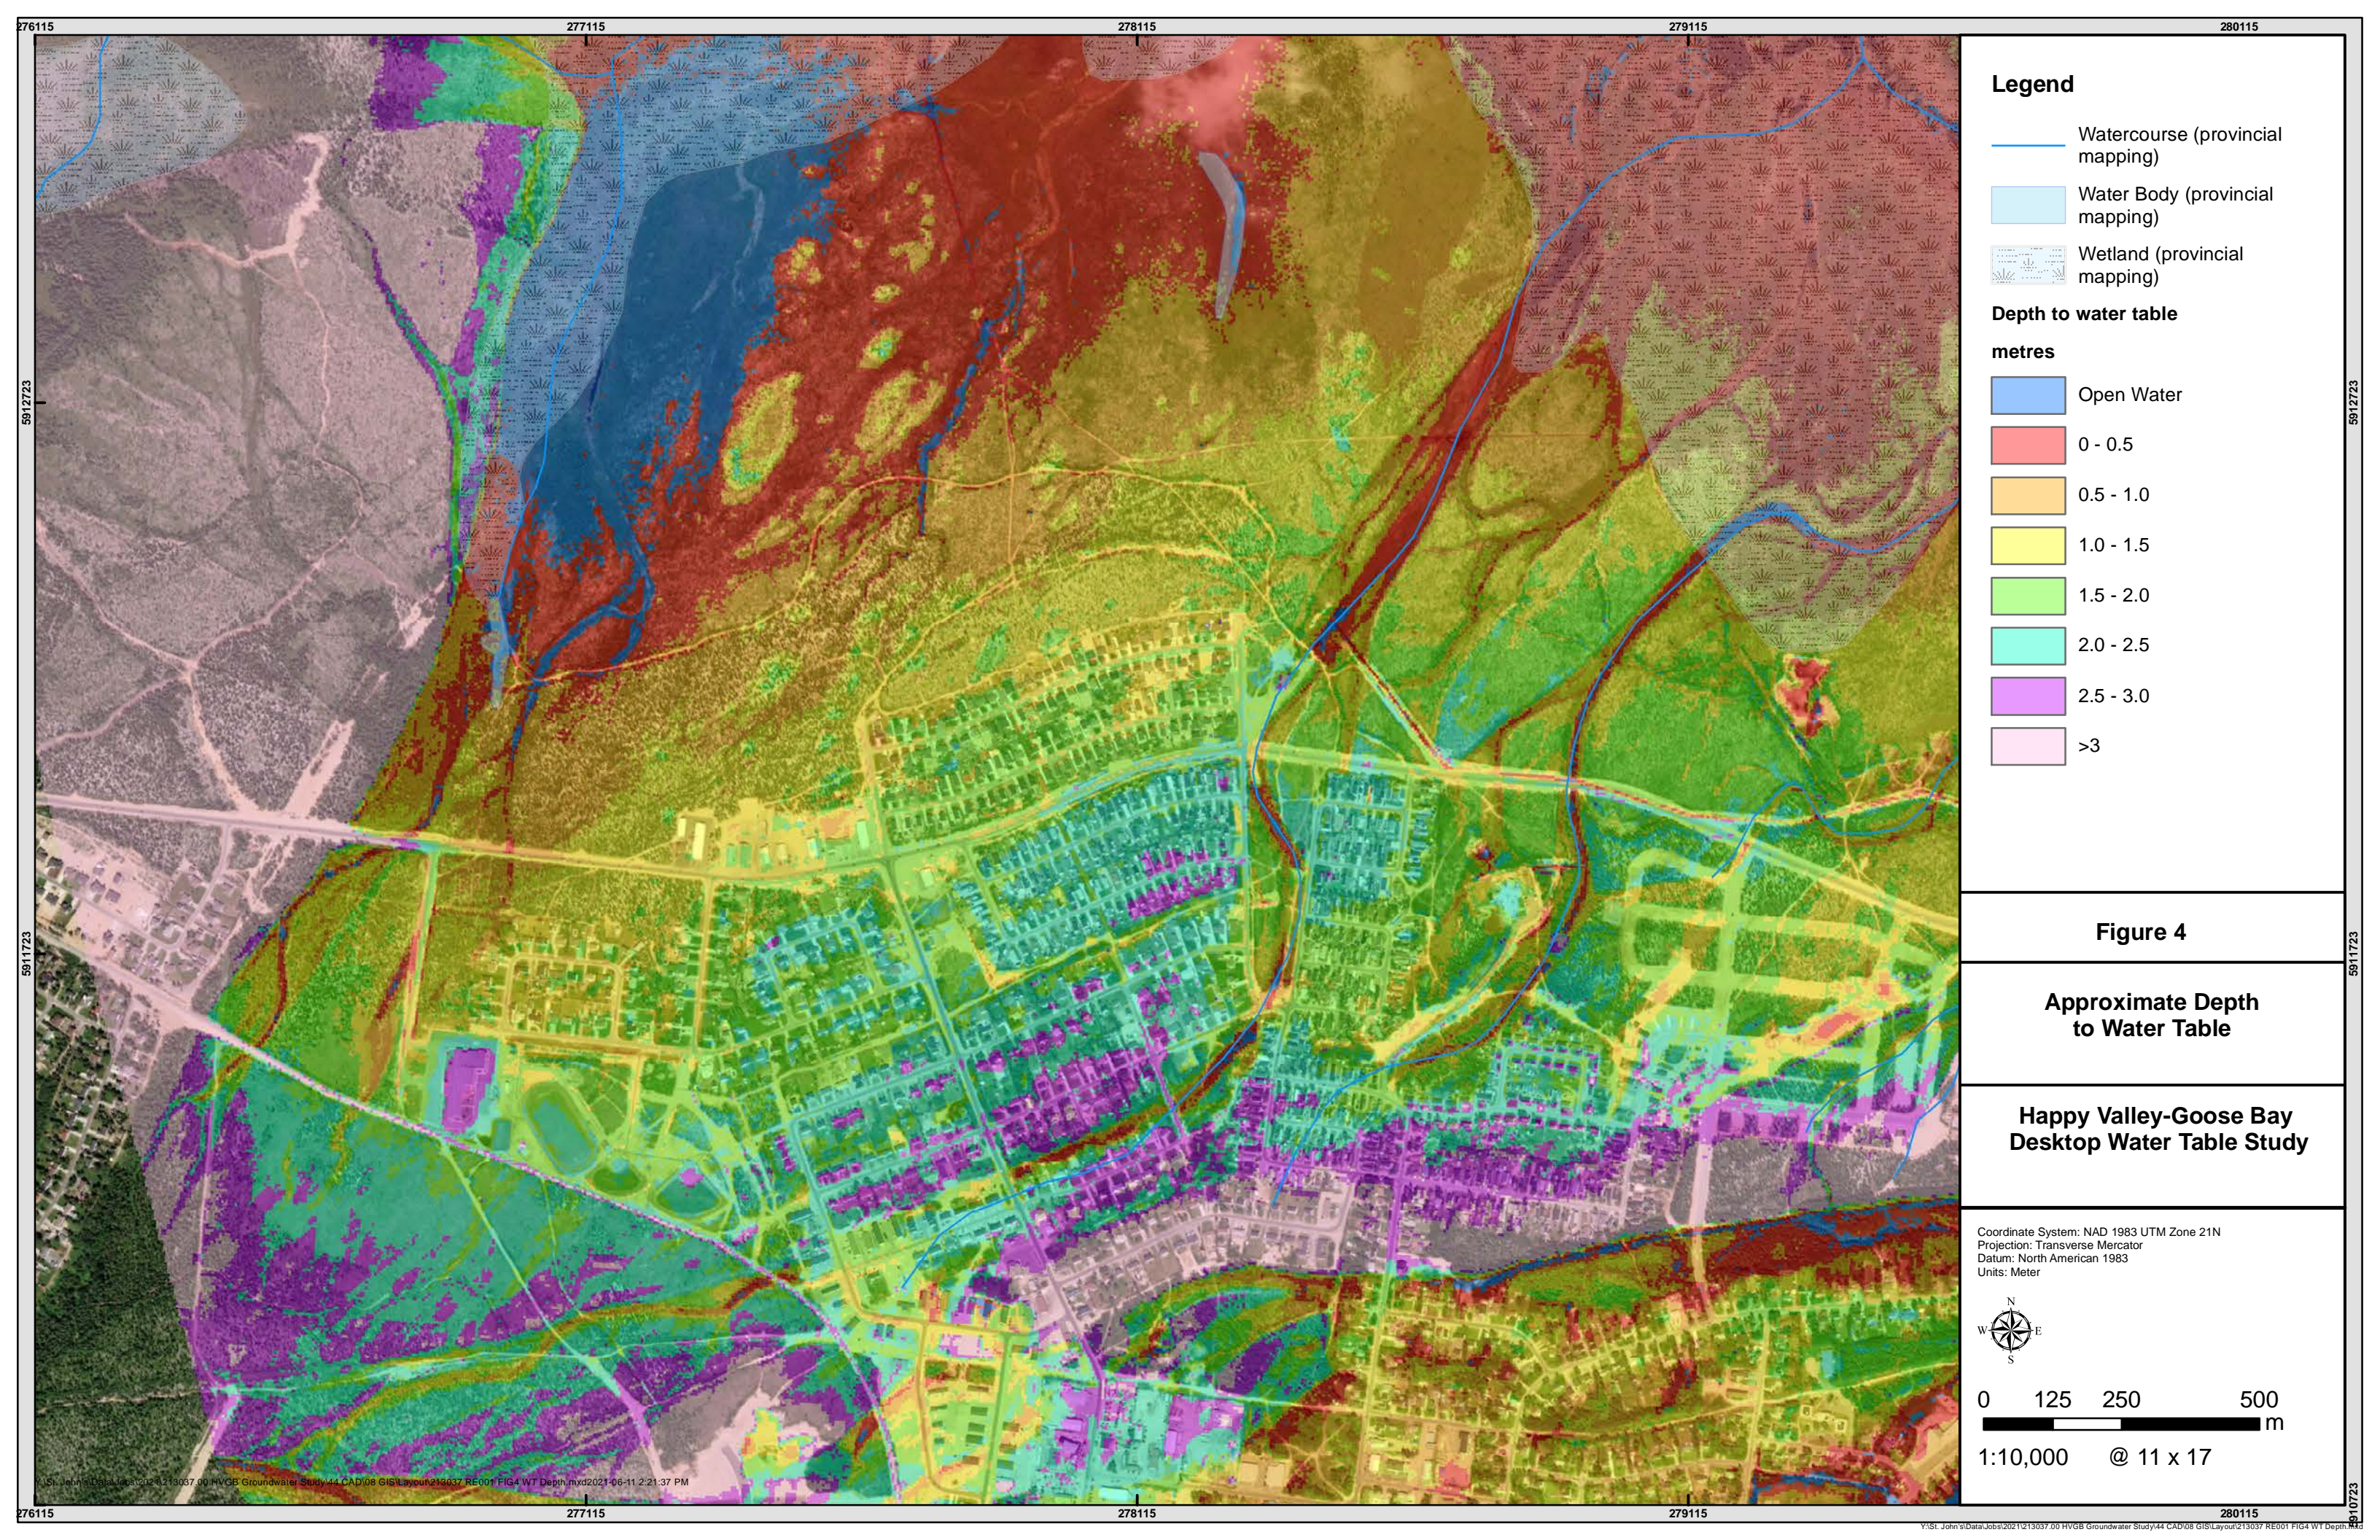
The interpolated water table surface was compared to the ground surface elevation to generate a map of the depth to the water table, shown in Figure 4. The depth to the water table decreases from its apparent greatest thickness (>3 m) on White Crescent, northward toward the wetland complex. Areas further to the south are lower-lying and appear to be associated with a relatively shallow water table. Figure 4 indicates that the water table depth in the Pottle-Mitchel subdivision is on the order of 1.5 metres. Basement crawlspaces in this area are reported to be approximately 1 metre below grade, suggesting that crawlspaces should on average be dry, but that as the water table rises, flooding becomes more likely to occur. Figures 3 and 4 do not capture the variability of the regional and local water tables. Figure 4 suggests that full basements in this area are likely to be below the regional water table, which would be associated with more consistent flooding.

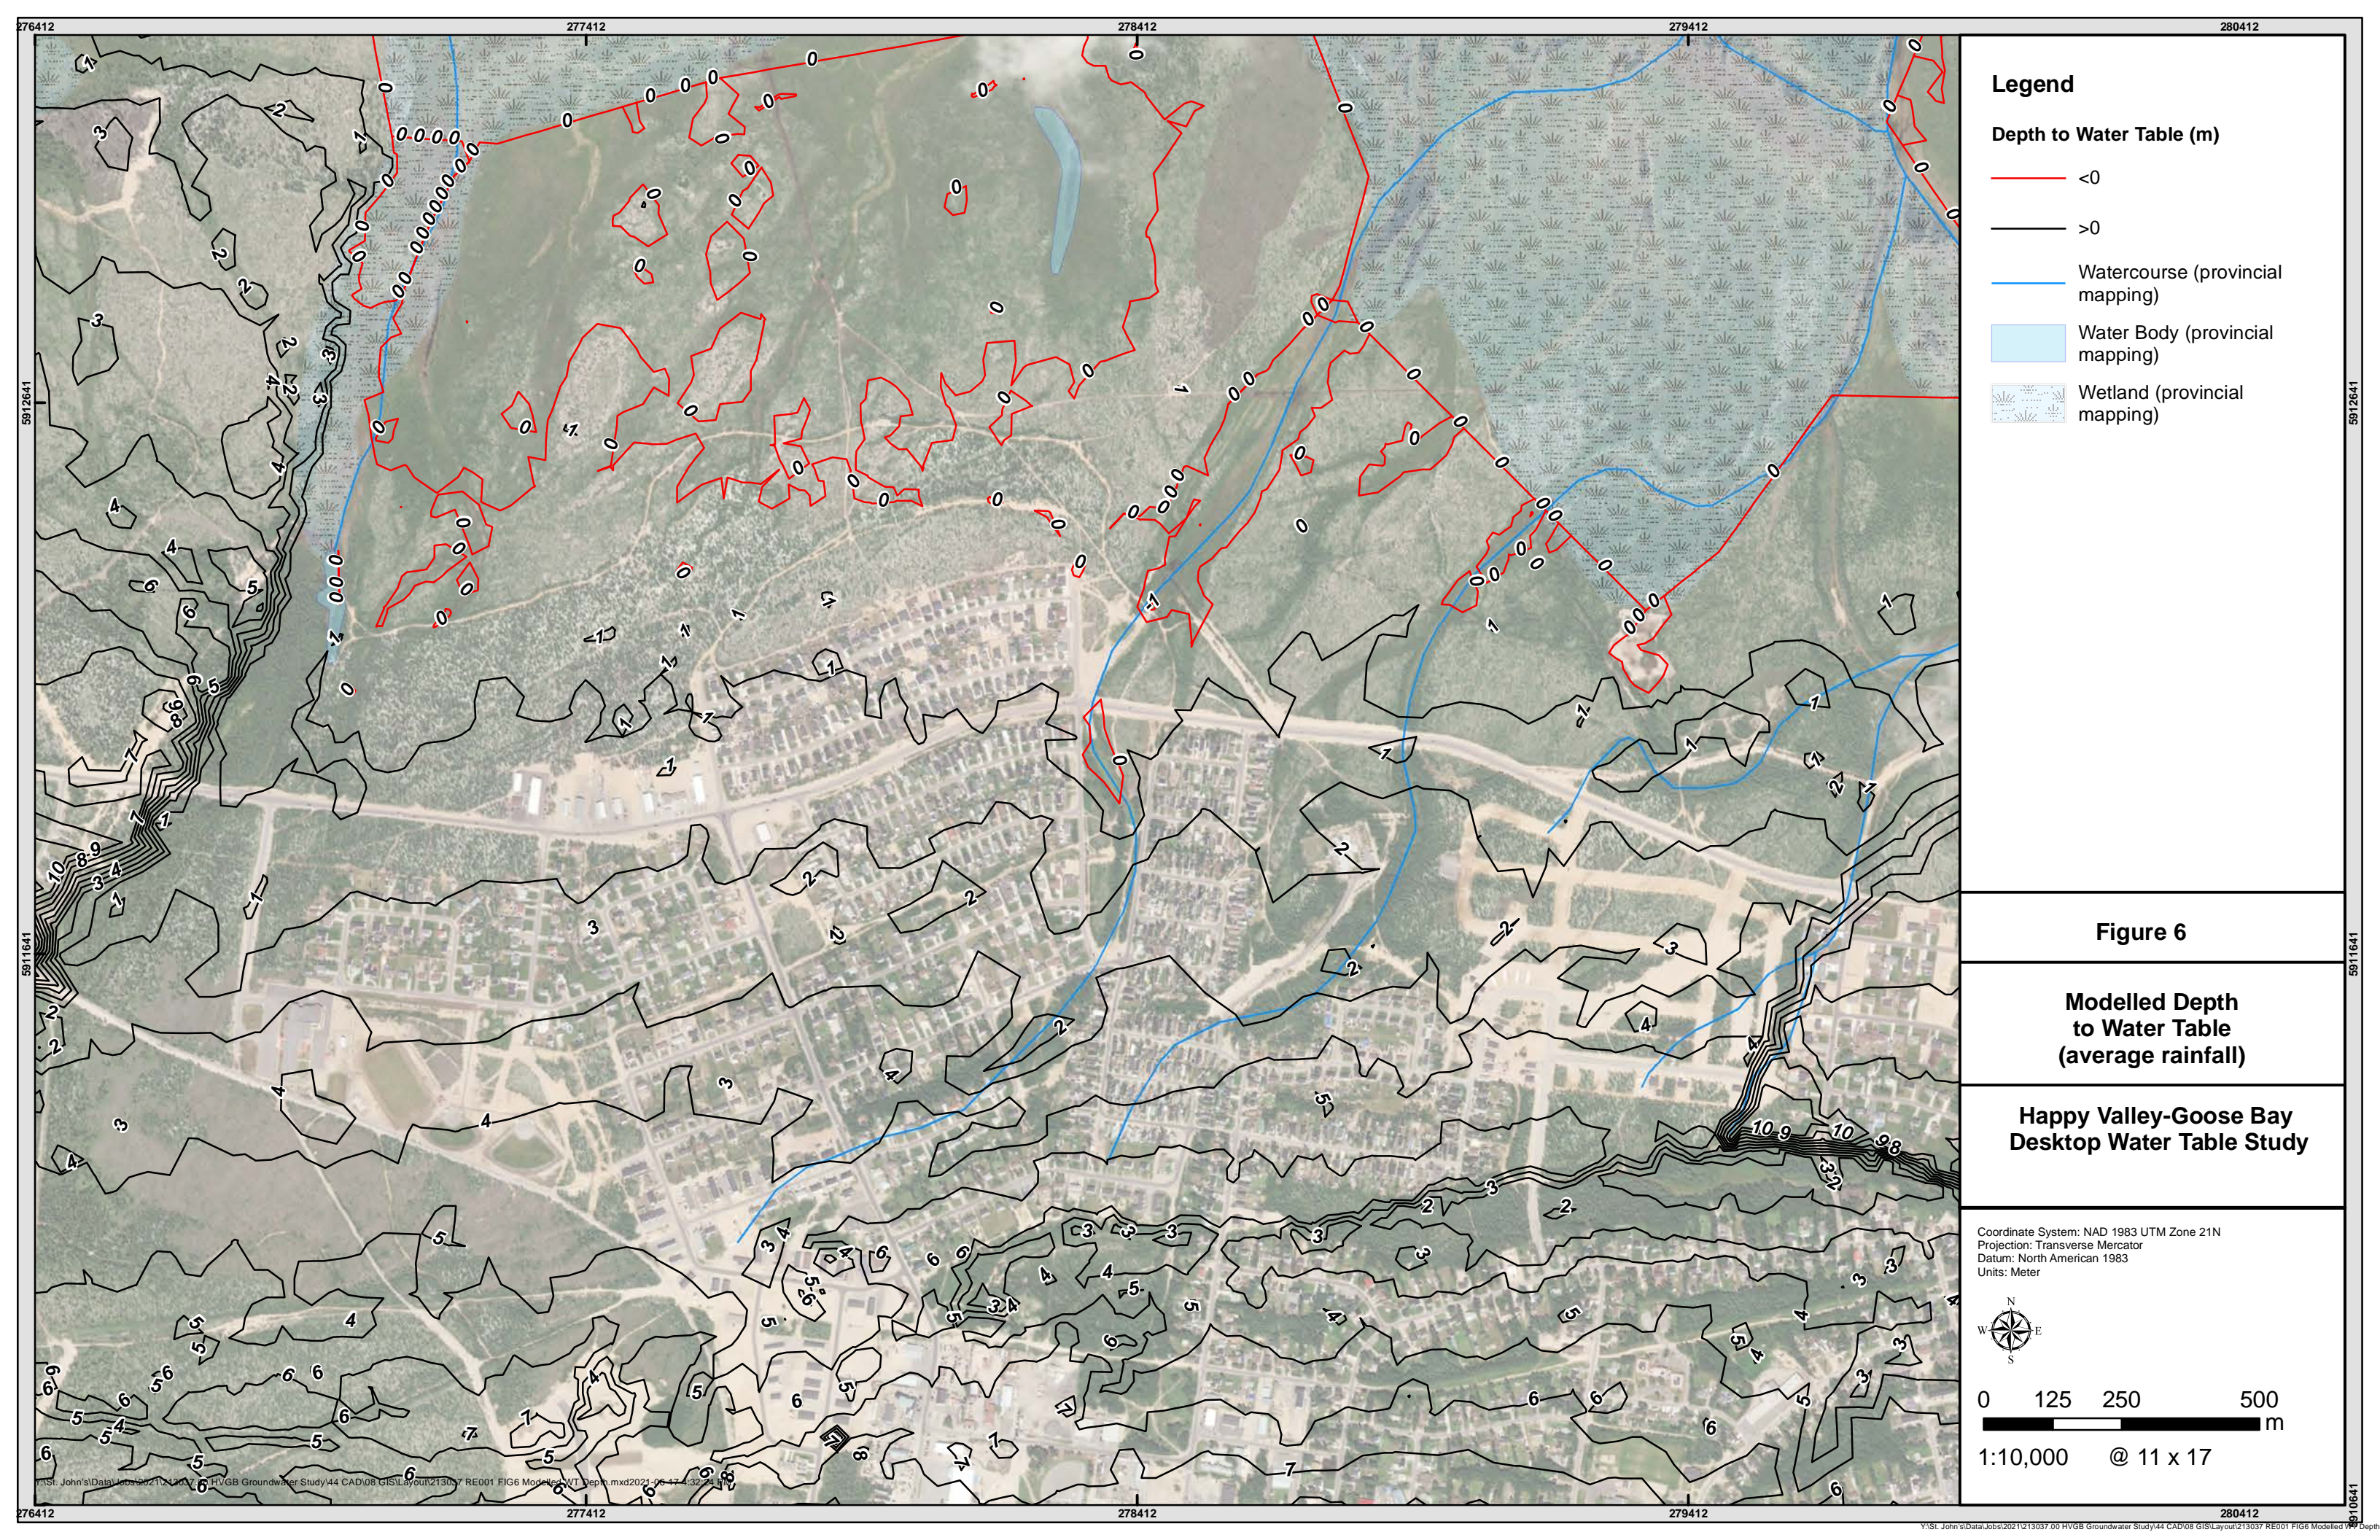
Figure 6 shows the theoretical depth of the water table under conditions of average rainfall. The modelled depth to the water table is generally consistent with the results of the Lidar analysis shown in Figure 4. The depth to the water table in the Pottle-Mitchell subdivision was on the order of 1.5 metres, decreasing for homes furthest to the north and east. Figure 7 shows the modelled depth to the water table with a moderate increase in rainfall, consistent with conditions observed in the springtime or after periods of extended rainfall in July and August. The scenario demonstrated in Figure 7 suggests that the water table could reach the ground surface with only moderate increases in rainfall or meltwater. These results did not include scenarios involving a perched water table (related to a deep frost zone).

Typical measures to manage basements below the water table include a combination of impermeable barriers, drainage pipe, and sump pumps. The results of this study suggest that an internal or external drainage system would be required for each building, and that continuous pumping would be required. Site-specific work would need to be completed to determine if this water could be discharged effectively without recirculation.
