RE: *Desktop Water Table Study*
Town of Happy Valley-Goose Bay

Happy Valley-Goose Bay Desktop Water Table Study

Project No: 213037.00

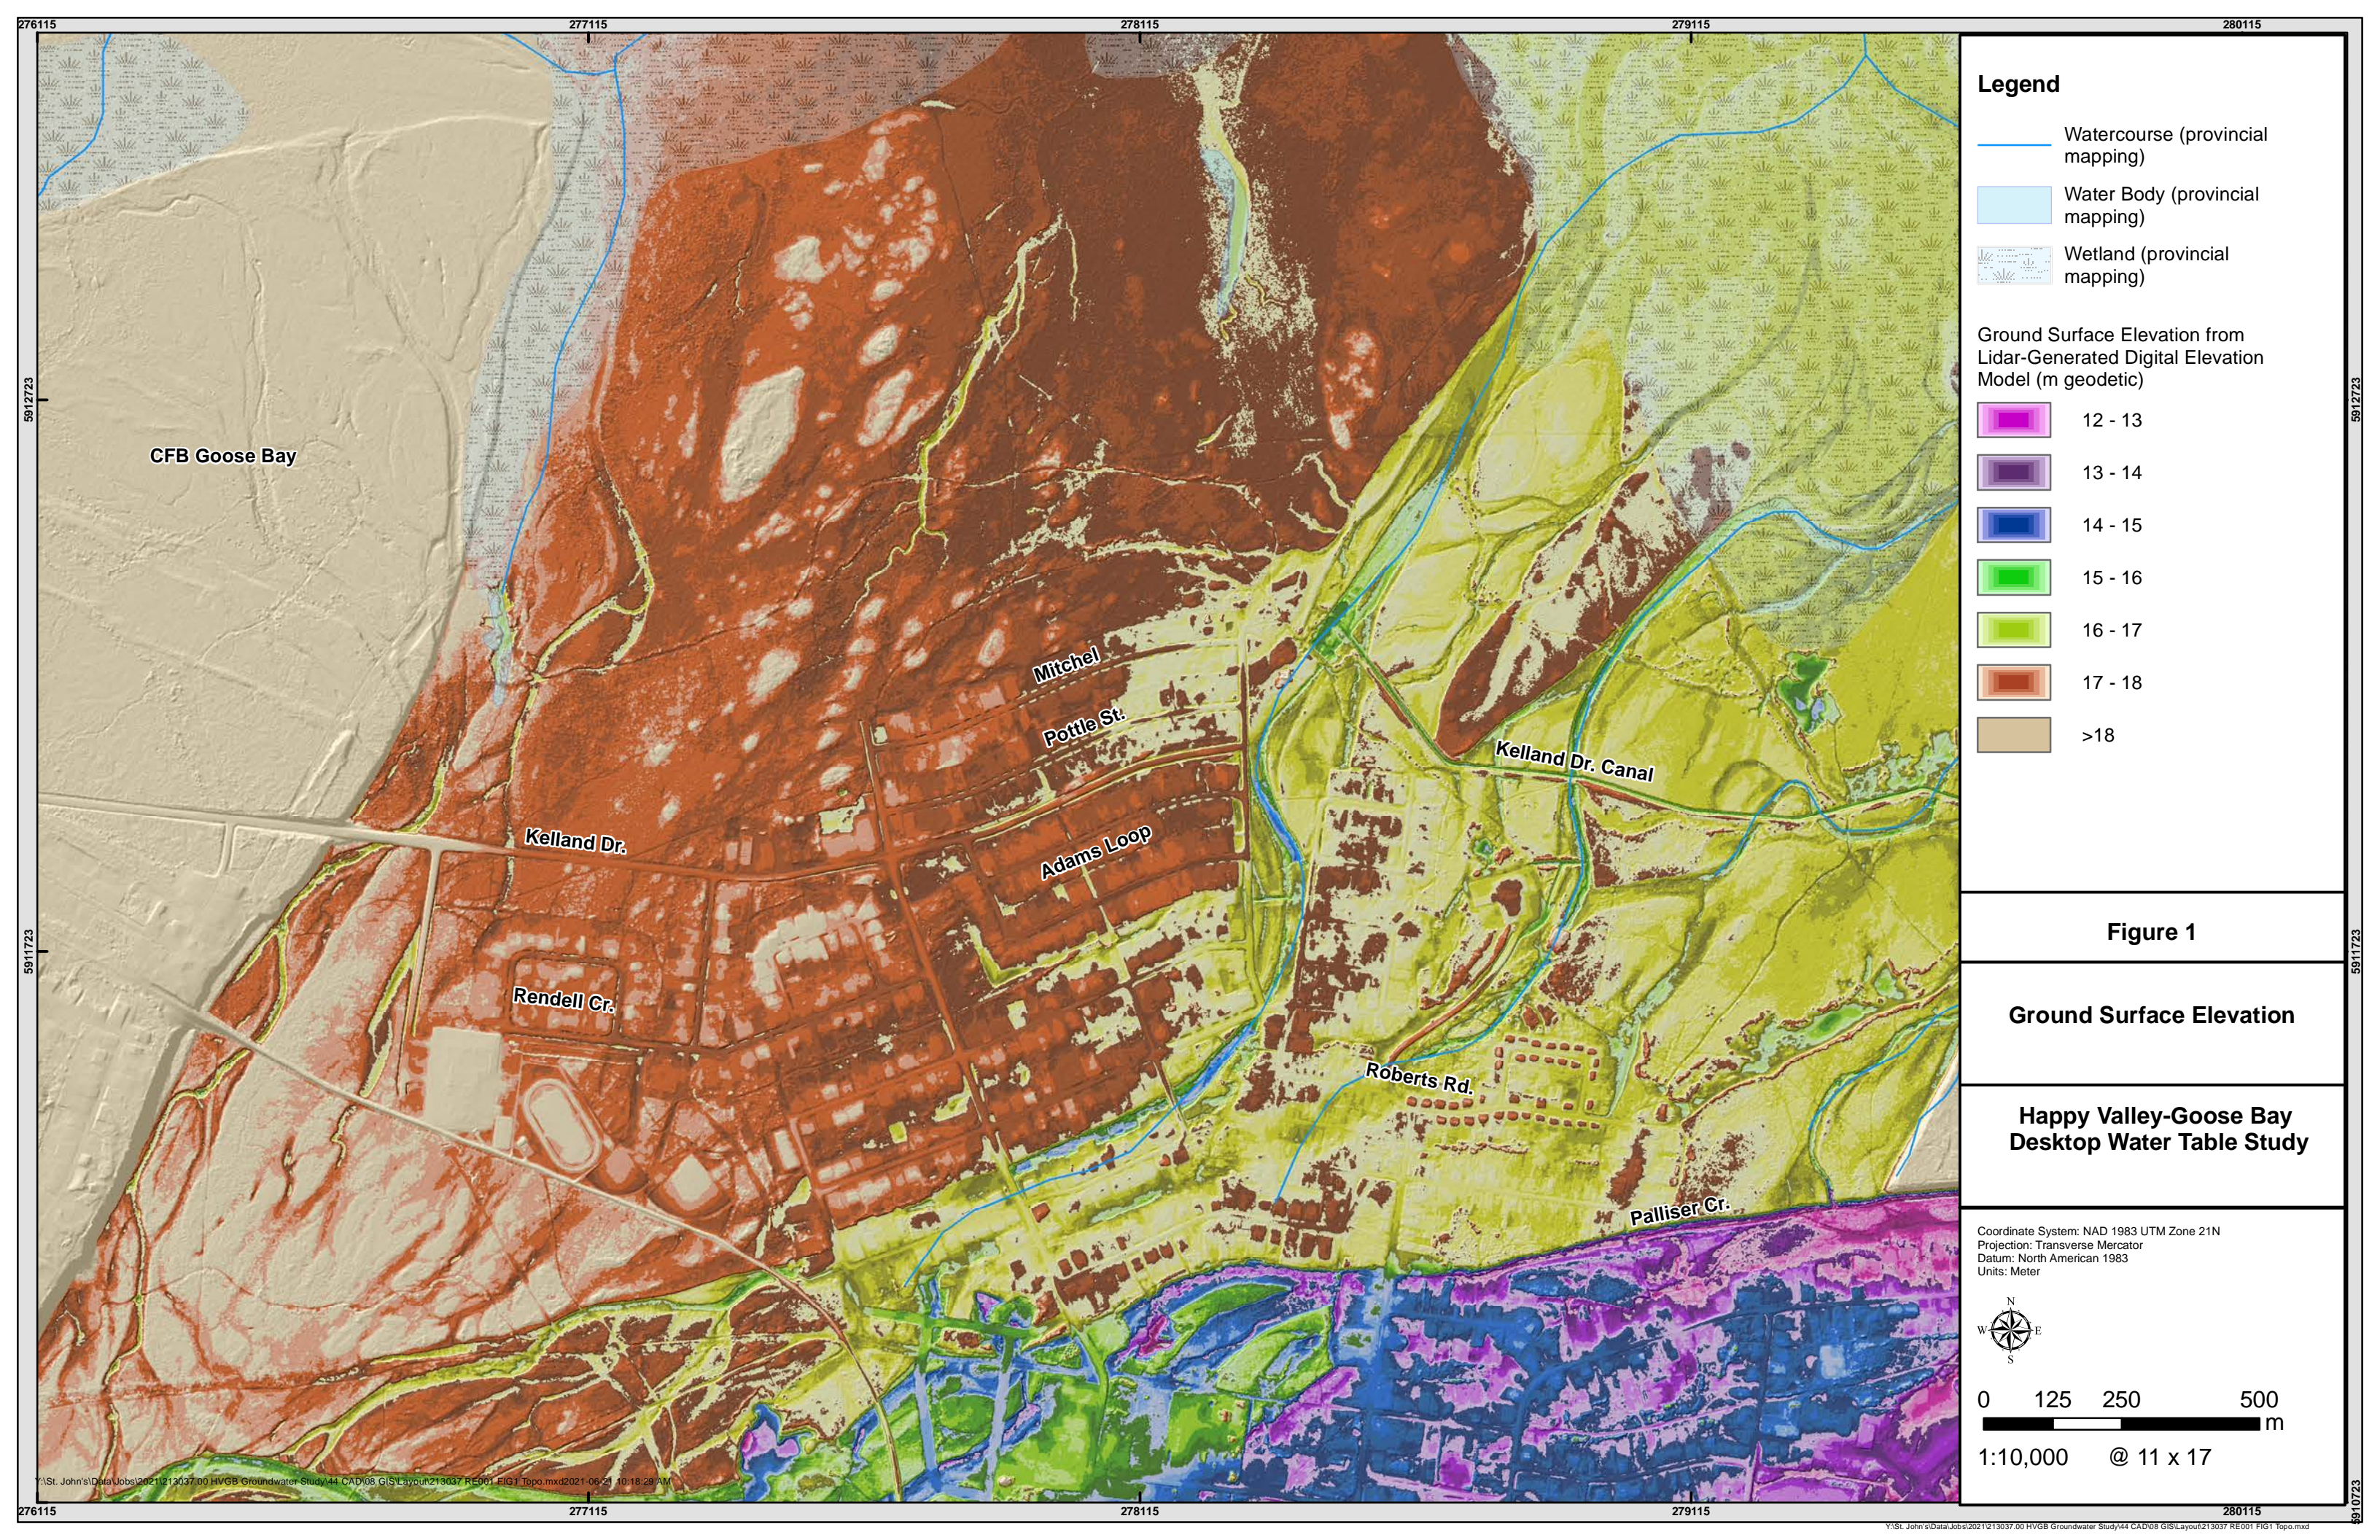
Figure 1

The study area is located within the Happy Valley-Goose Bay rift valley (Figure 1). The Town is situated on the southern half of a five- to six-kilometre-wide isthmus that projects eastward from CFB Goose Bay, bounded by the Churchill River to the south, and Lake Melville to the north. These saltwater bodies are tidally influenced.

Ground Surface Elevation

sea level at the coastline. CFB Goose Bay occupies a terrace further to the west, situated at elevations of up to 50 metres geodetic. Select problem areas within the town are situated at elevations from 15 to 17 metres.
